# FINAL REPORT

## Infrared Reflectance Imaging for Environmentally Friendly Corrosion Inspection Through Organic Coatings

ESTCP Project WP-0407

MAY 2008

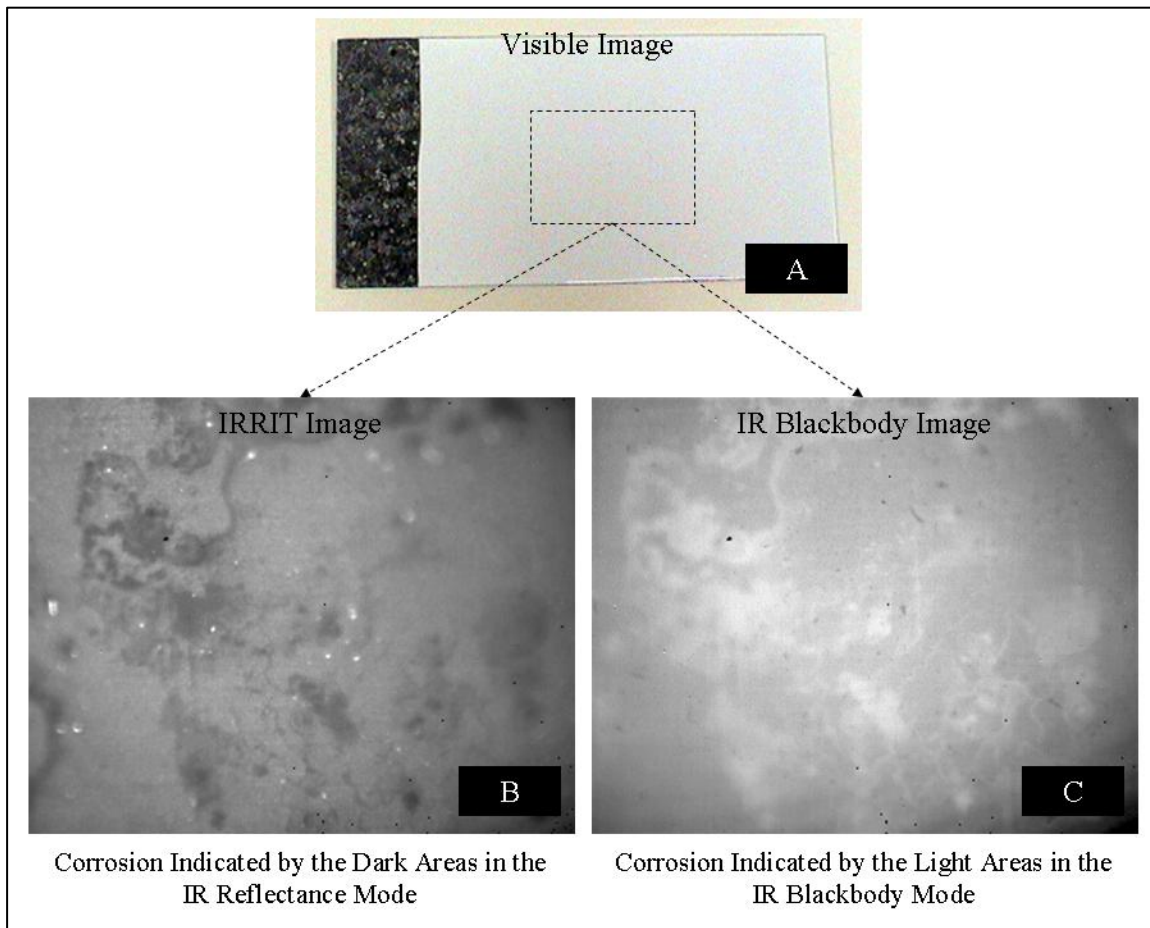
**Figure 2-4: IR Reflectance versus IR Blackbody**

It is important to understand the image differences between IR reflectance and the blackbody modes. Figure 2-4 (A) is a standard visible light image of a painted corroded aluminum panel illustrating exposed corrosion on the left hand side with the right side being corrosion that has been painted with epoxy primer and gloss urethane color insignia white. The corrosion can not be seen under the coating, except when observed with IR as illustrated in Figure 2-4 (B and C).

In the reflectance mode, as illustrated in Figure 2-4 (B), the observed corrosion is denoted by the dark areas while in the case of the Blackbody Mode the observed corrosion is white.

Comparing both Figure 2-4 (B and C) and superimposing them over each other, it can be clearly seen that the dark patterns match the light corrosion patterns in the respective figures. These facts lead to an interesting possibility that if the IR heat flux of the corroded areas equals the IR heat flux of the non-corroded areas, the corrosion will not be observable and hence the corrosion would not be detected through the coating. In fact, this is a distinct possibility that could be encountered in the field by the camera operator. Such a scenario could occur while using the IR camera system in the IR reflectance mode. For example, a hot metallic aircraft structure would emit IR energy in the blackbody mode with the corrosion appearing light such as in Figure 2-4 (C). If an IR reflectance method using IR illuminators is employed the corrosion will appear dark, as previously demonstrated, provided the corrosion area does not emit more energy than the background in reflection. The potential issue is that if the illuminators do not provide enough IR flux to be reflected from the non-corroded background, this background will appear darker provided the blackbody mode dominates the IR reflectance mode. The corroded area may appear to be the same with respect to the background brightness or the corroded area in the IR reflectance mode would emit energy in the blackbody equal to the energy being reflected by the IR reflectance heaters in the non-corroded area. This would create a condition of zero contrast and hence no corrosion will be observed by the IR

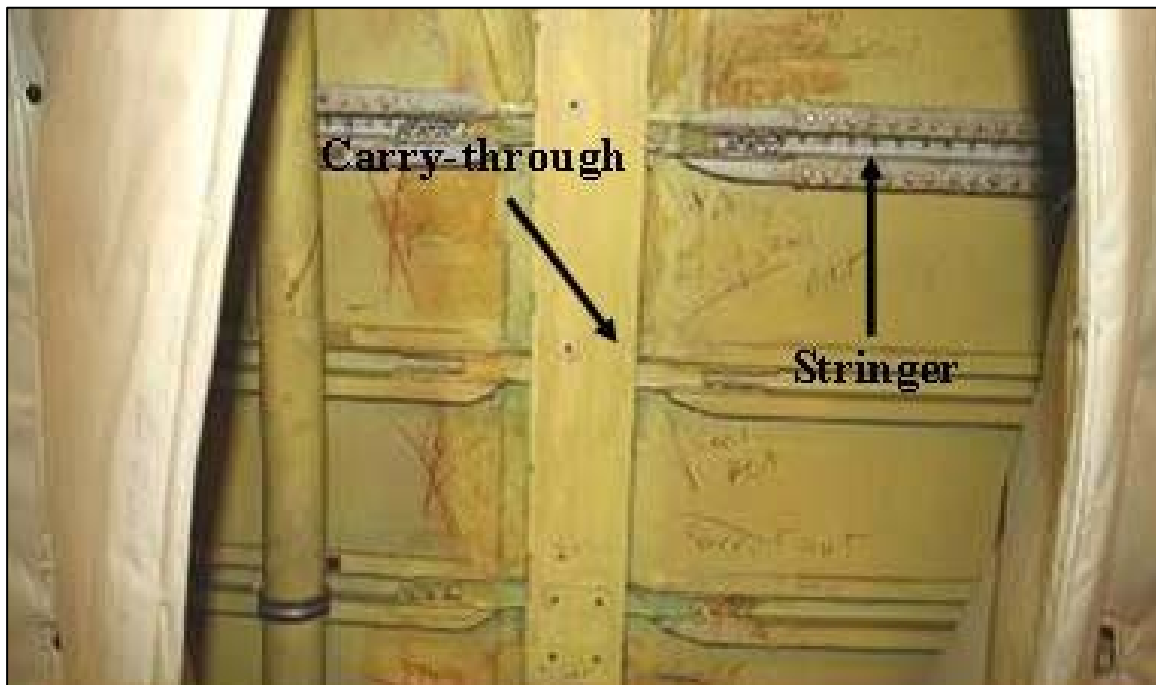
**Figure 3-13: KC-135 IML IRRIT Inspection Area**

the KC-135 was not regularly stripped of paint, so paint stripping will be limited to areas where the IRRIT identifies corrosion. Areas of interest in the KC-135, as illustrated in Figure 3-13, include:

The KC-135 areas of interest were internal structural components. The “horseshoe fittings” are load-bearing members that help distribute loads from one wing to the other, wrapping around the diameter of the fuselage like vertical horseshoes. Several similar structural frames (“formers”) had been identified as areas of interest to KC-135 maintenance personnel. Finally, the “carry-throughs” that connect “stringers” (light structural frames running lengthwise inside the skin of the aircraft) through the formers had also been identified as prone to corrosion and cracking. Wing spars were also considered, but preliminary tests during the 19 April 2006 visit to OC-ALC demonstrated that the many hydraulics and secondary structural components made access difficult with the current FLIR camera. The total inspected area would be about 100 square feet per aircraft.

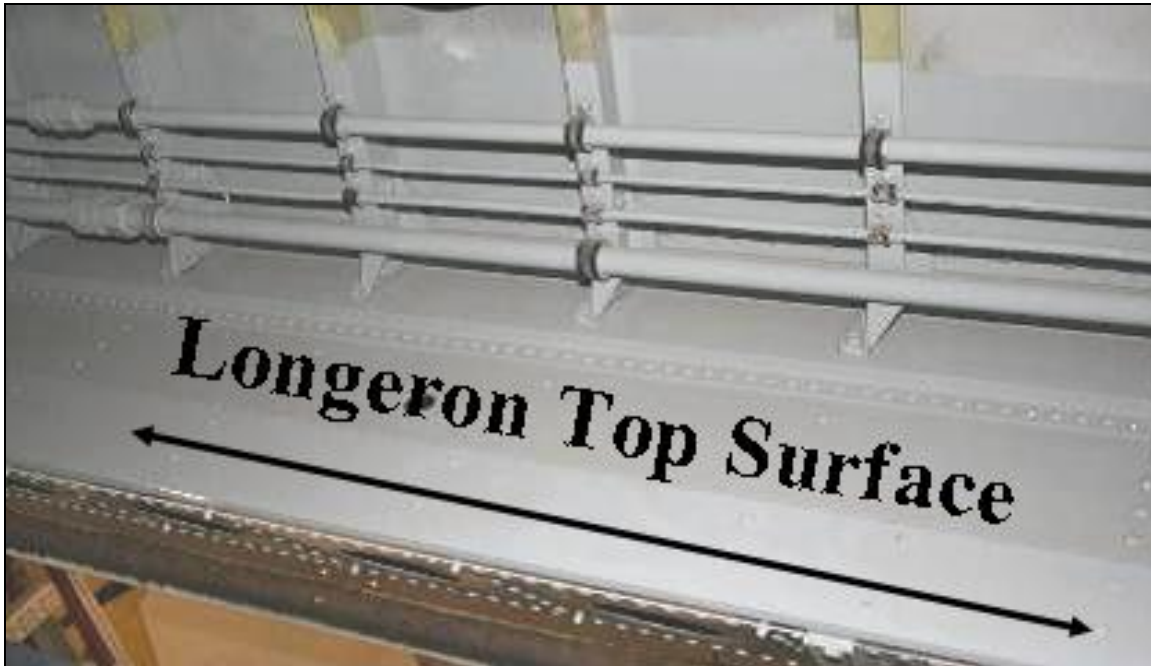
**Figure 3-14: B-52 IML Bomb Bay Longeron**

The B-52 areas of interest were in the bomb bay, partly due to their corrosion issues (they are exposed to outside weather conditions) and partly due to their accessibility and minimal interference with maintenance schedules. Within the bomb bay, the primary target was the longerons (heavy lengthwise structural members) at the bottom sides of the bay. The total inspected area was about 40 square feet or less. Unlike the KC-135 inspections, the longerons have previously been stripped and repainted for corrosion control purposes.

Inspection of B-52 #1's bomb bay longerons yielded a few suspected corrosion locations during IRRIT inspection. Eight corrosion locations were identified. After being stripped of paint, 7 proved to be corrosion. It is suspected that the corrosion was so minor on one of the locations that it was removed during the chemical stripping process.

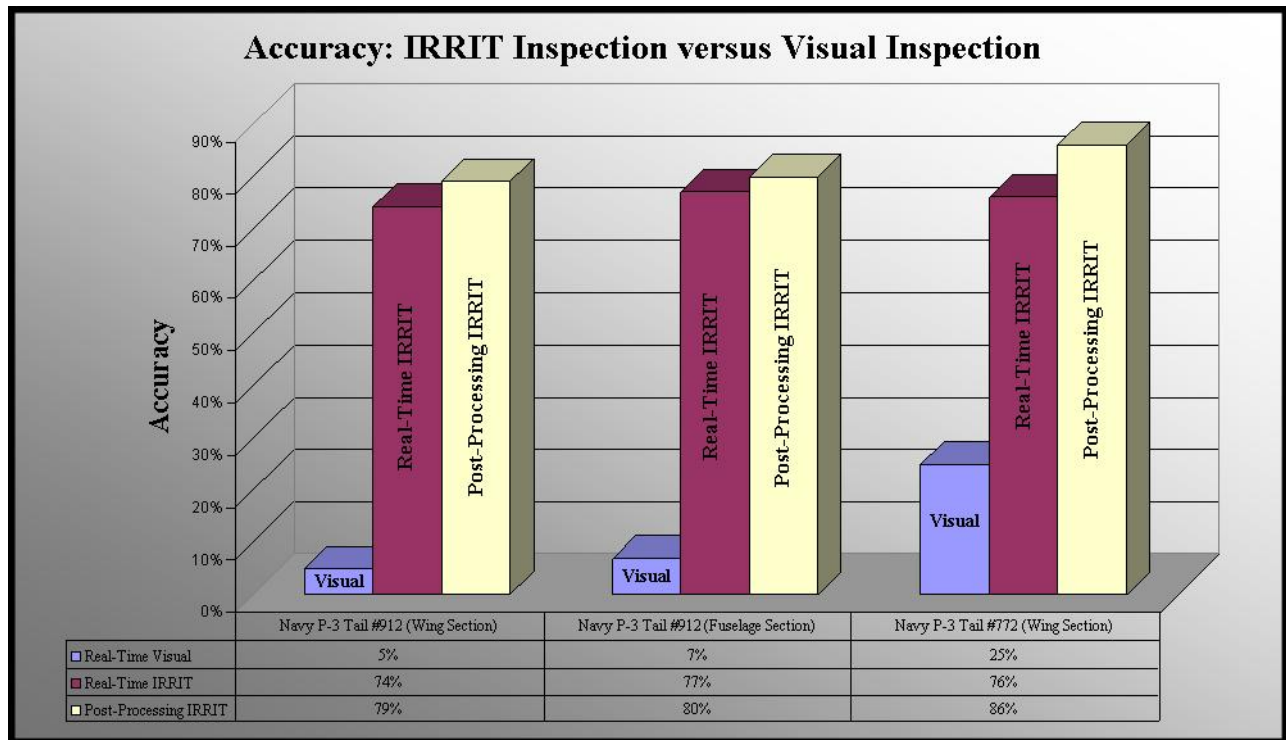
**Figure 4-10: Navy P-3 OML - Accuracy of IRRIT Inspection versus Visual Inspection**

Figure 4-10 illustrates the high level of accuracy of the IRRIT inspection method (79%, 80%, and 86% Post-Processing IRRIT) as compared to the visual inspection method (5%, 7%, and 25% Real-Time Visible), during the Navy P-3 OML Dem/Val. The IRRIT inspection identified three times (3X) the amount of corrosion located by visual inspection. The IRRIT as compared to the visual inspection method allows for post-processing the images after the inspection, which can assist the identification of corrosion present but not observed during the real-time inspection. Probable IRRIT inspection errors can be found in Table 4-3.

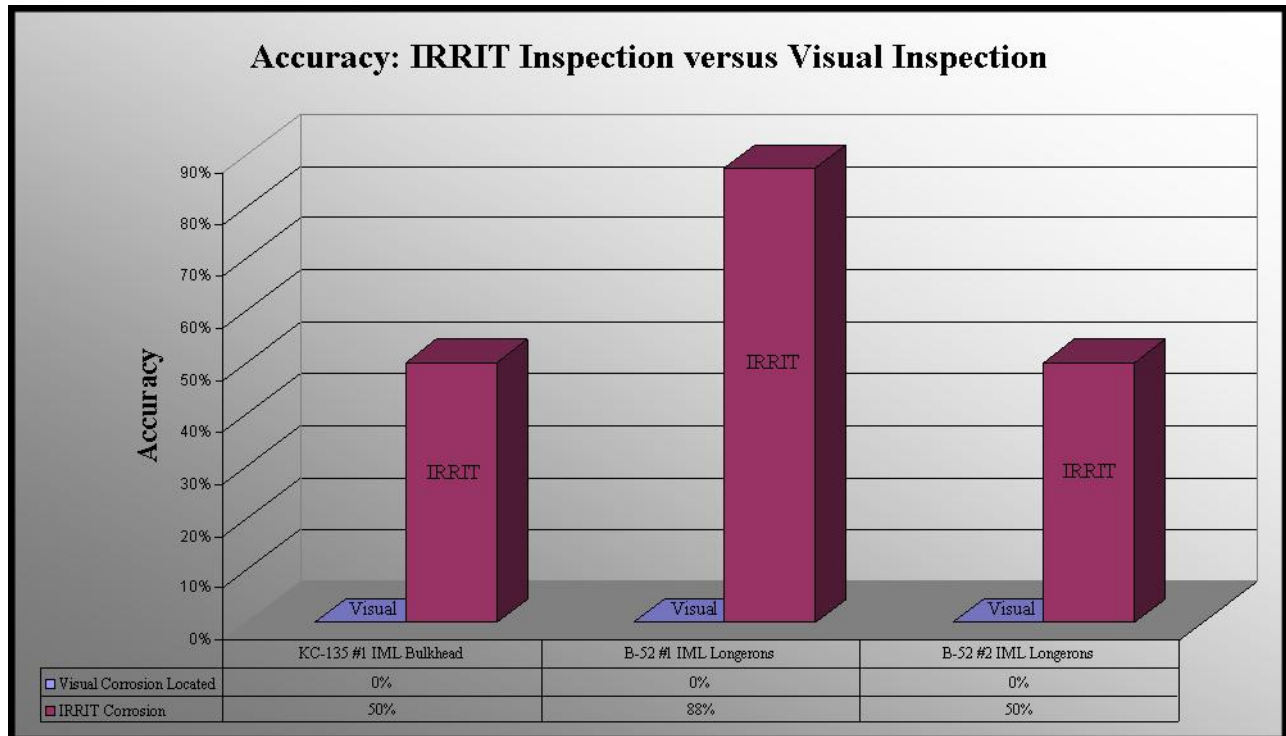
**Figure 4-11: KC-135/B-52 IML - Accuracy of IRRIT Inspection versus Visual Inspection**

Figure 4-11 illustrates the high level of accuracy of the IRRIT inspection (50%, 88%, and 50%) method as compared to the visual inspection method (0%, no corrosion visually noted), during the USAF KC-135 and B-52 IML Dem/Val. During this Dem/Val the inspected aircraft had low levels of corrosion, thus reducing the data set that was recorded. No corrosion was detected via visual inspection, whereas IRRIT successfully identified several corrosion locations. Probable IRRIT inspection errors can be found in Table 4-7.

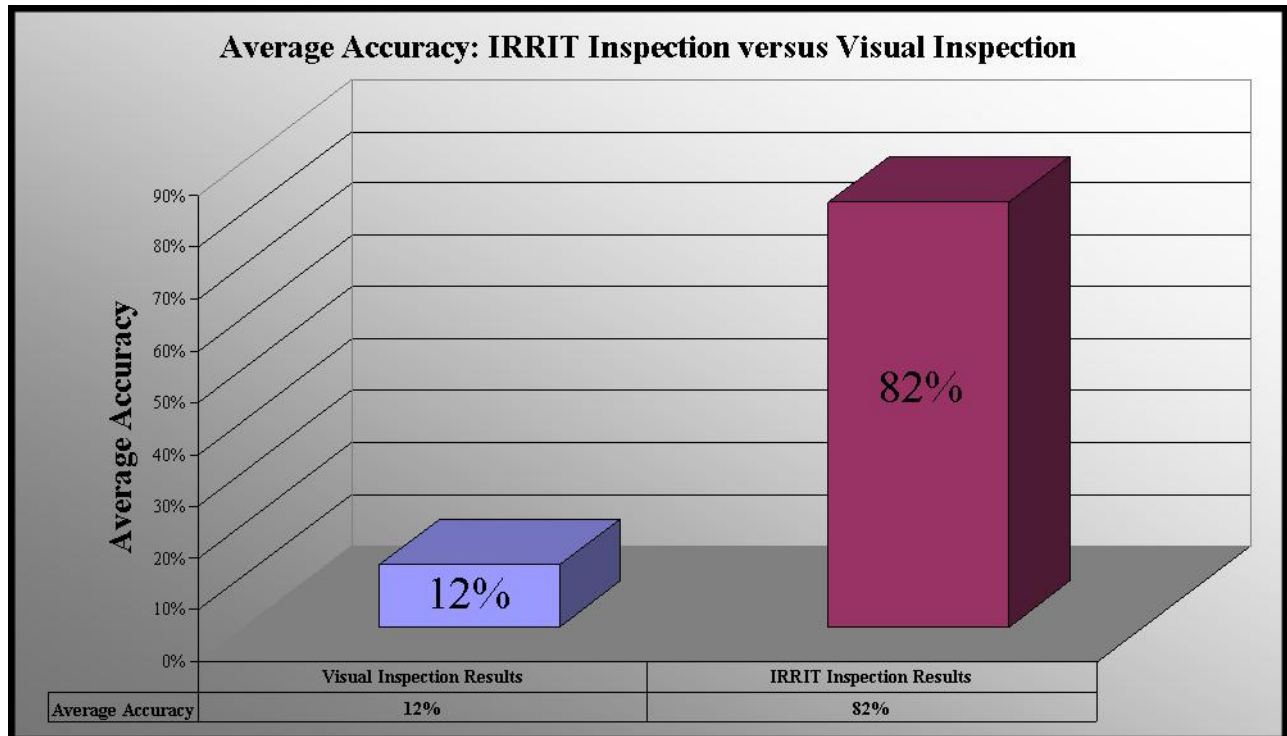
**Figure 4-12: Average Accuracy of IRRIT Inspection versus Visual Inspection**

Figure 4-12 illustrates the average level of detection, comparing visual inspection versus IRRIT inspection. This is a weighted average, where all corrosion sites were weighted equally for both OML and IML Dem/Vals. This chart illustrates the high level of accuracy of the IRRIT inspection method as compared to the visual inspection method. In total (including OML and IML Dem/Vals) there were 352 corrosion sites. The IRRIT found 287 corrosion sites out of the 352, equaling 82% accuracy. Visual inspection found 42 corrosion sites out of the 352, equaling 12% accuracy.

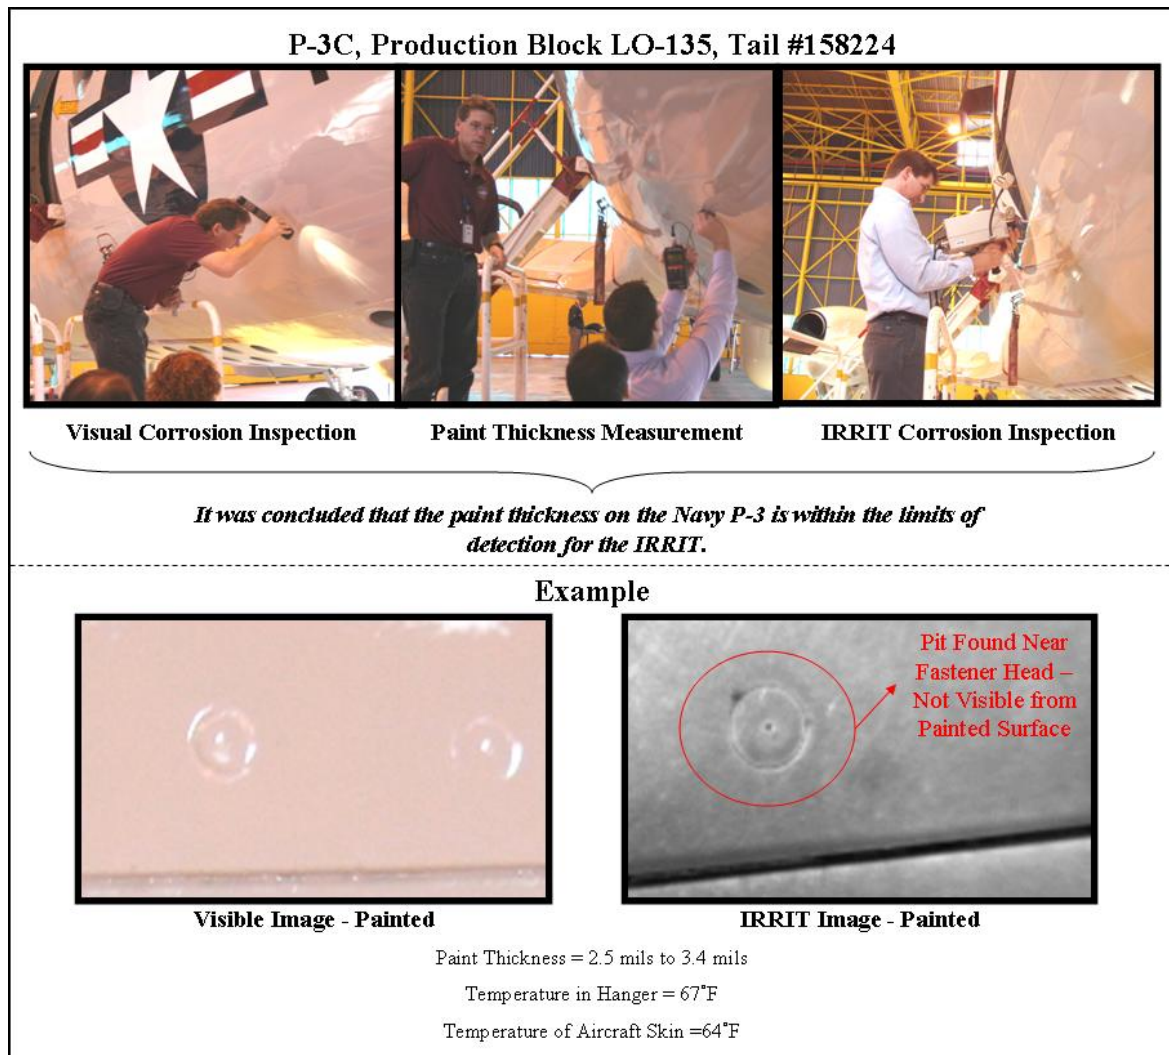
The objective of this trip was to demonstrate a final risk reduction of the IRRIT system, prior to beginning the Dem/Val on the Navy P-3 in February 2006. This objective was achieved and the IRRIT system successfully imaged through the coating system that is currently used on the Navy P-3 aircraft (refer to Figure B-1).

**Figure B-1: Risk Reduction at NAS Jacksonville**

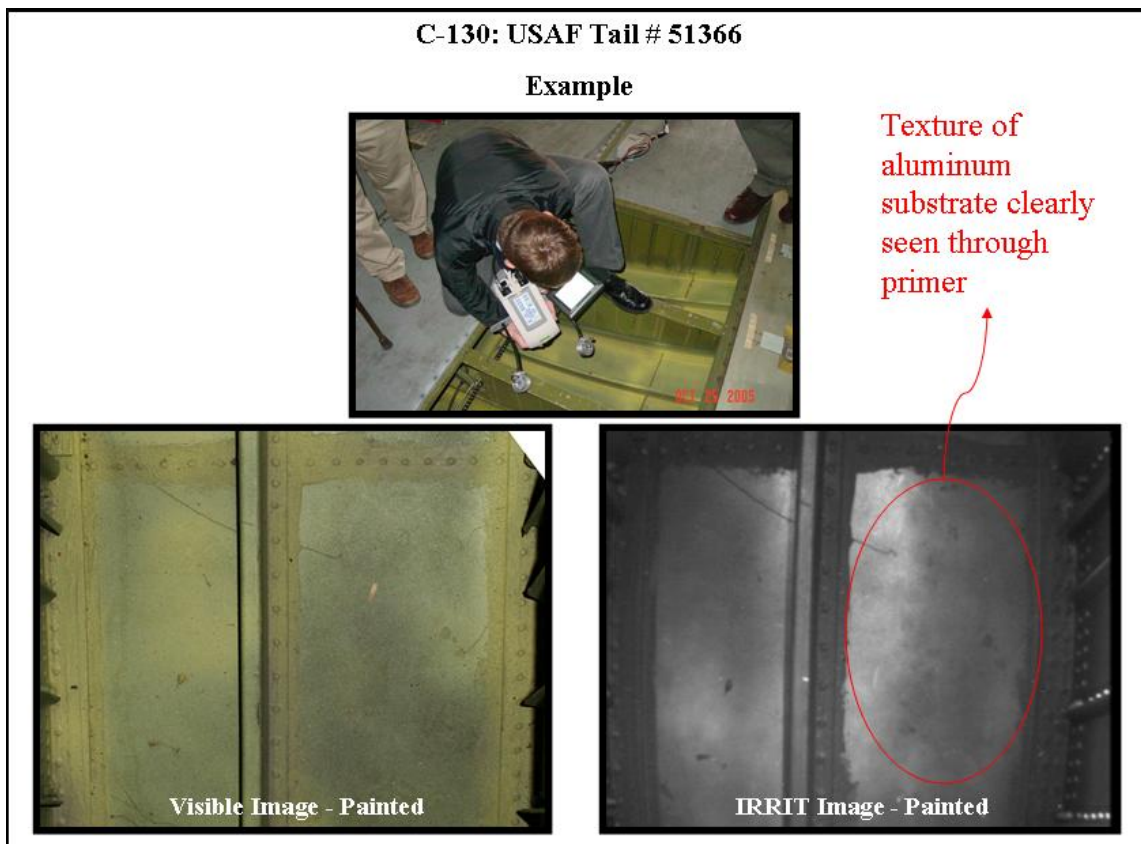
**Figure B-4: Substrate Texture Under IML Coating of C-130**

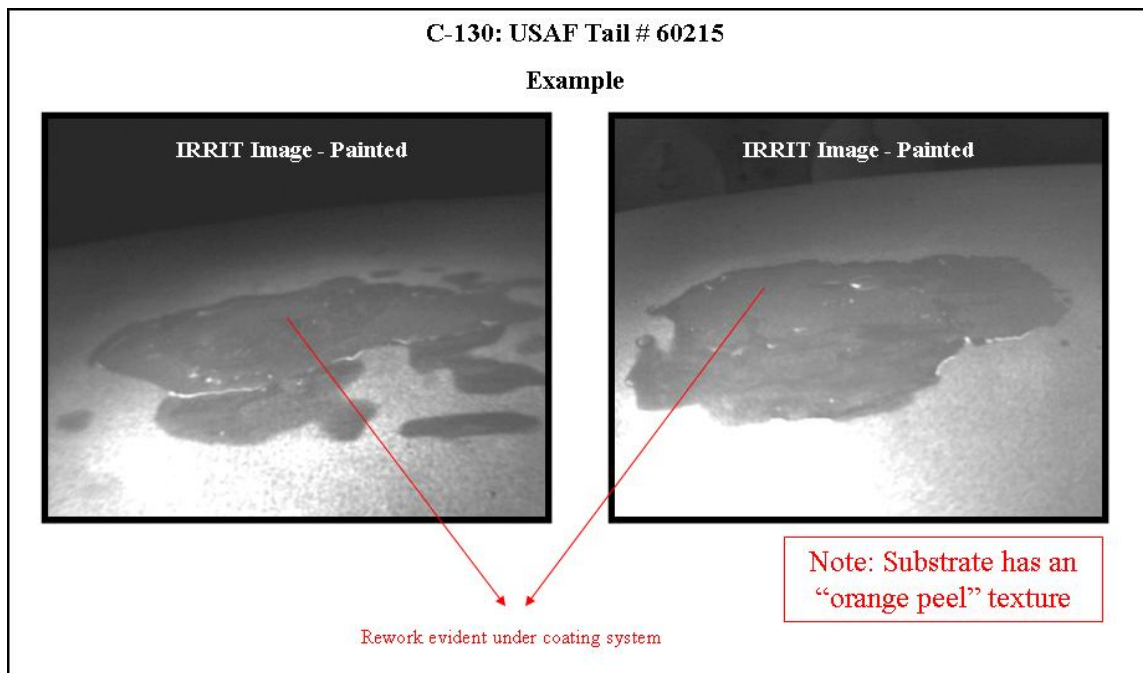
- Demonstrated IRRIT system on C-130 aircraft (C-130 USAF Tail # 60215). The fourth survey was of another C-130 (USAF Tail # 60215) exhibiting coating thicknesses approximately 3.5-9 mils on exterior sections. Both IR photographs and conventional photographs were taken on this exterior location (refer to Figure B-5). The IRRIT system successfully imaged through the thinner coated sections of the aircraft. However, the IRRIT system was unable to image through the thicker coated sections.

**Figure B-5: Rework Under OML Coating of C-130**

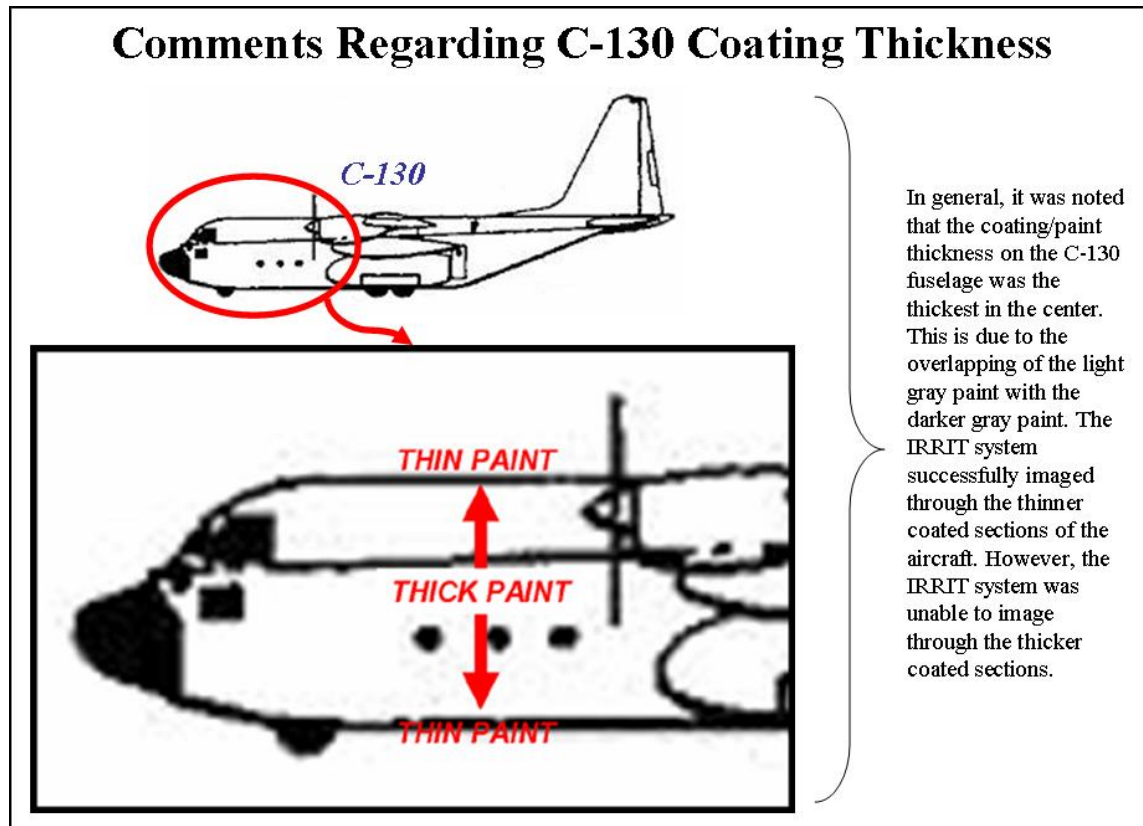
Figure B-6: Coating Thickness on C-130 OML

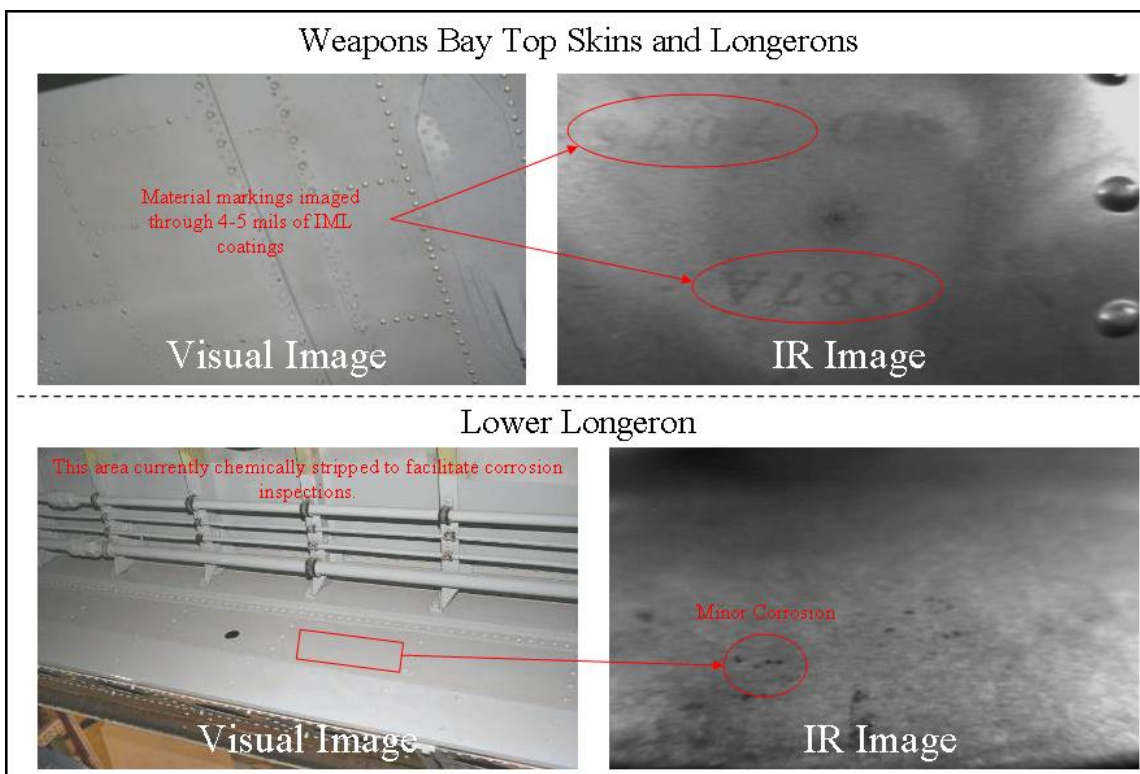
**Figure B-8: B-52 IML Visual and IR Images**
